Manhole Inspection Summary

Manhole # S23K__008MH

Insp Date: **6/12/08 7:21 AM**

Location Address: **240 S Calhoun St**

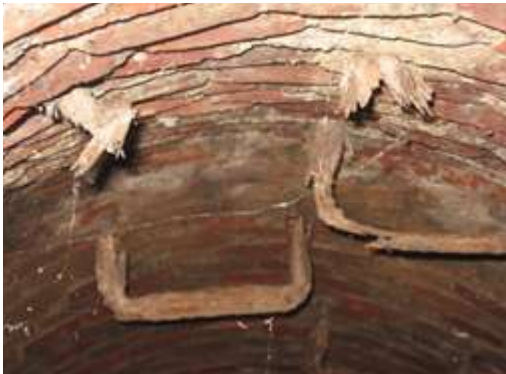
Defect 1

Count: **5** Missing: **2** ☒ **Corroded**

corroded and missing rungs

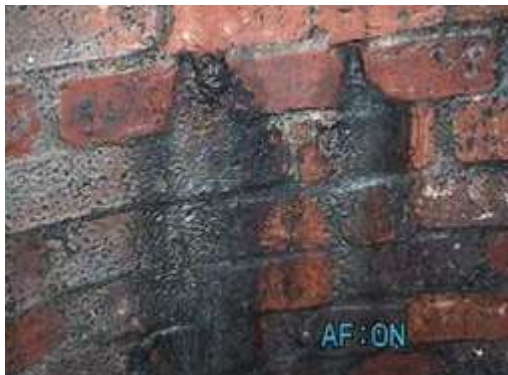
Defect 5

Infiltration: ☐ None ☐ Joint ☐ Cracks ☒ **Mortar** ☐ Roots ☐ Wall

barrel infiltration at mortar

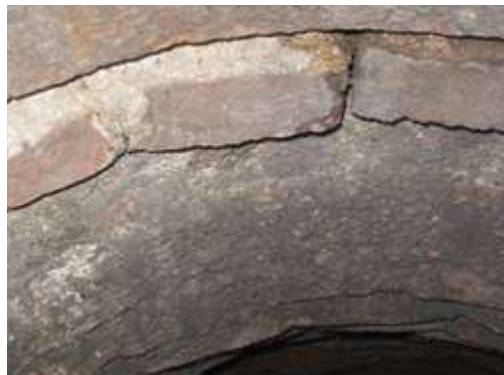
Defect 3

Condition: ☐ Sound ☐ Cracked ☐ Root Intrusion ☒ **Loose Brick** ☐ Deteriorated

Infiltration: ☐ None ☐ Joint ☒ **Cracks** ☒ **Mortar** ☐ Roots ☐ Wall

chimney loose bricks with signs of infiltration at crack & mortar

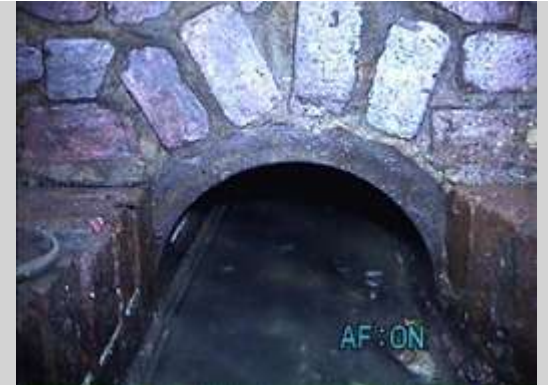
12 O'Clock Outflow

8 in. Circular Gravity Sewer
Pipe Out @ 12 O'Clock

Pipe Height: **8.4** (in.) Rod and Bar (Angled)
Pipe Material: **Clay** ☐ Pipe Lined
Invert Depth: **8.58** (ft.) Flow Characteristics: **Slow**
Deposits: ☒ None ☐ Mud ☐ Sludge ☐ Debris ☐ Grease
Silt Depth: **0** (in.) Deposits Extent:
Infiltration: **None** Pipe Seal Cond: **Sound**

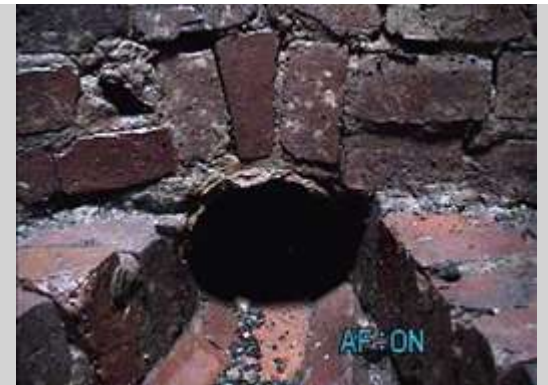
2 O'Clock Inflow

6 in. Circular Gravity Sewer
Pipe In @ 2 O'Clock

Pipe Height: **6** (in.) Rod and Bar (Angled)
Pipe Material: **Clay** ☐ Pipe Lined
Invert Depth: **8.28** (ft.) Flow Characteristics: **None**
Deposits: ☒ None ☐ Mud ☐ Sludge ☐ Debris ☐ Grease
Silt Depth: **0** (in.) Deposits Extent:
Infiltration: **None** Pipe Seal Cond: **Sound**

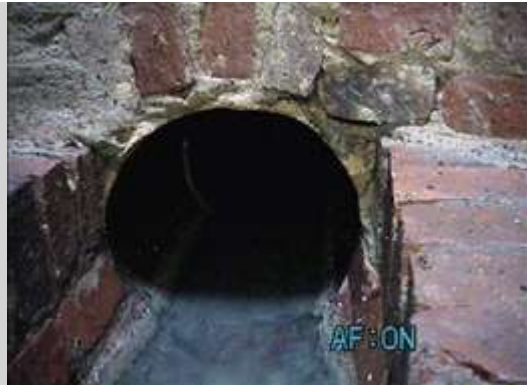
5 O'Clock Inflow

10 in. Circular Gravity Sewer
Pipe In @ 5 O'Clock

Pipe Height: **10.8** (in.) Rod and Bar (Angled)

Infiltration: **None** Pipe Seal Cond: **Sound**
